SEASONAL SWIM DOCK ALTERNATIVES ANALYSIS

Connecticut River at Dartmouth College

MMI #4459-01

January 21, 2011

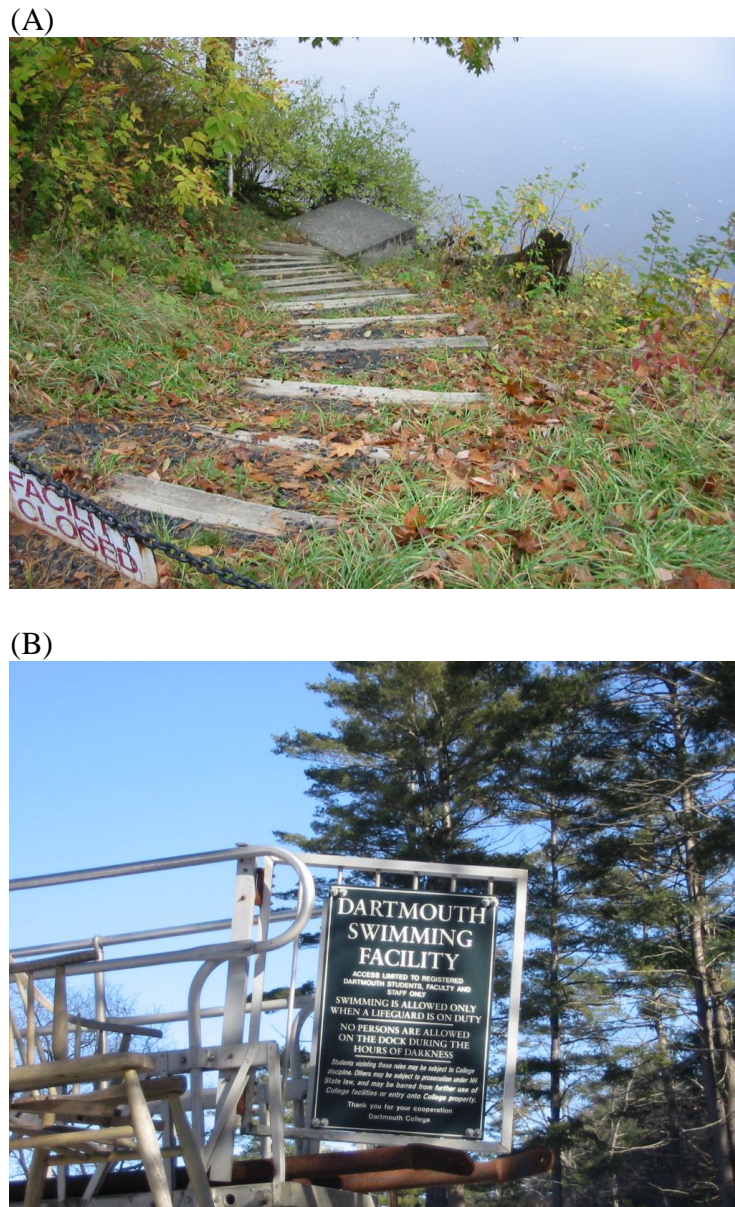
Figure 3: (A) Trail and wood retaining blocks leading to the existing concrete swim dock anchor. (B) Signage on the gated entrance to the gangway leading to the existing dock that is currently in storage on the riverbank.

The docks are accessed in a single location by a steep gravel trail with four-inch x four-inch wood retaining blocks that bring swimmers from the edge of the existing parking lot to a concrete block (Figure 3A). A three-foot wide aluminum gangway with railings connects the concrete block on shore to the dock surface. The slope on the gangway is steep (approximately one foot drop every two feet) and varies with the water surface elevation in the impounded river. A gate exists at the entrance to the gangway that has a facility and safety sign mounted on it (Figure 3B).

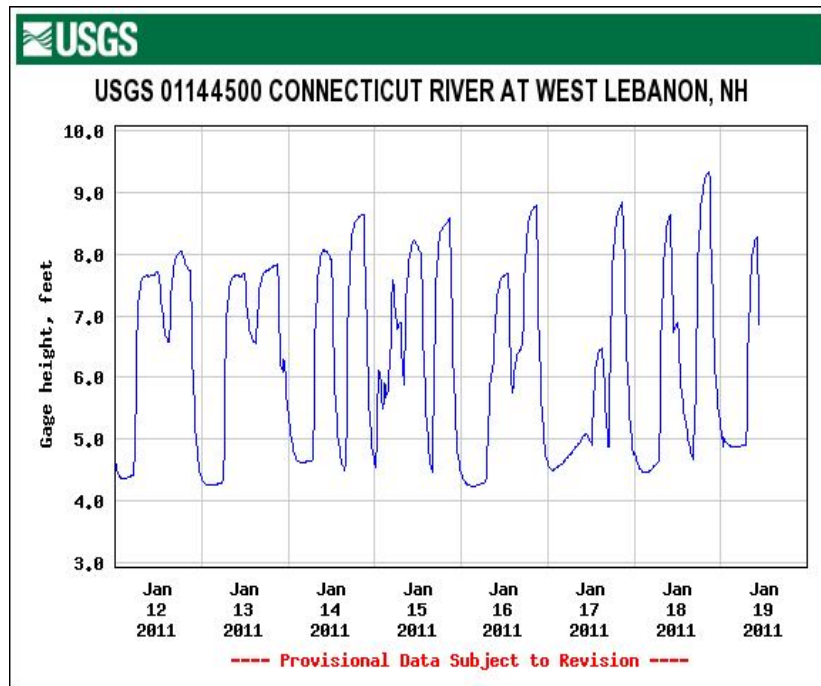
Figure 5: Changing water surface elevation downstream of Wilder Dam.

of-river is when gate operations are not used to retain or release water beyond what occurs from the dam alone. A modified run-of-river indicates that a water surface operating range has been provided to the facility for electrical generation by control over pool level and downstream flow rates. Peaking hydroelectric facilities store and release large amounts of water when electricity is needed and most expensive, and have the greatest impact on upstream water surface elevations. Wilder Dam has a five-foot operating range between 380 and 385 feet NGVD29 that it adjusts daily and, thus, operates as a daily peaking facility (Figure 5).

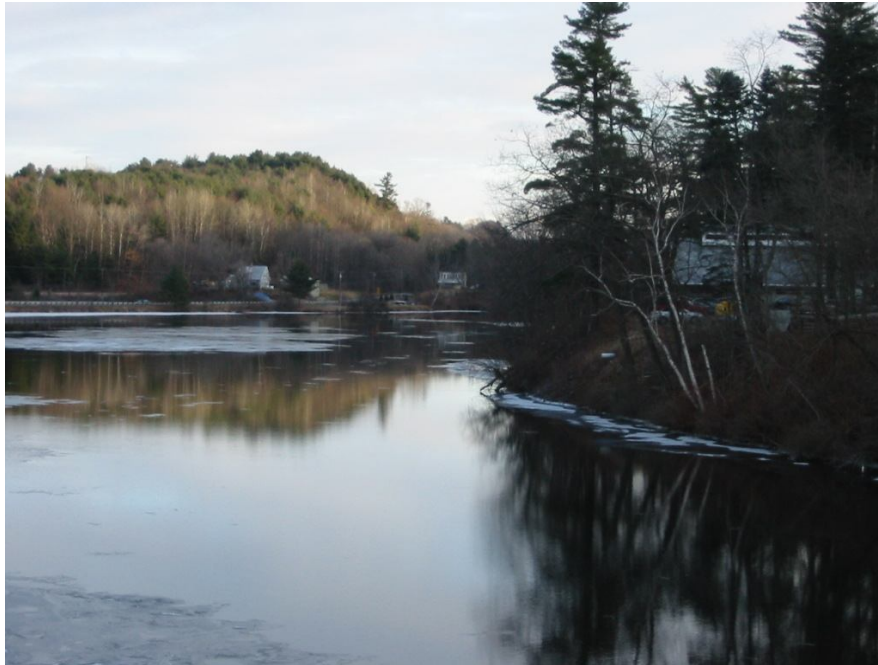
Figure 10: Upstream view of a possible new swimming location that is approximately 200 feet downstream of the existing swim dock location. This area is more sheltered from the main current as it is downstream of the meander apex, and the main current is in the center of the channel (to the left side of the photograph).

This area appears to be locally sheltered from flows and winds as the main current pulls off of the east bank toward the center of the channel (Figure 10). The minor difference in slope of the channel bottom does not substantially change the swimming scenario yet suggests that less erosion of bottom sediments is taking place due to the sheltered setting. This sheltered setting is likely to have less large woody debris than closer to the main current.
