## SEASONAL SWIM DOCK ALTERNATIVES ANALYSIS

Connecticut River at Dartmouth College

MMI #4459-01

January 21, 2011

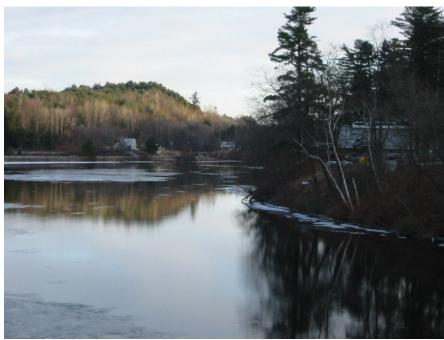
Figure 2: Upstream view of the preferred new swimming location that is approximately 175 feet downstream of the existing swim dock location. This area is more sheltered from the main current as it is downstream of the meander apex, and the main current is in the center of the channel (to the left side of the photograph).

The preferred alternative selected by the project team is to move the swimming dock approximately 200 feet downstream of the existing swim dock location and install the existing dock. This location is just downstream of the apex of a meander bend in the river channel and appears to be locally sheltered from flows and winds as the main current pulls off of the east bank toward the center of the channel (Figure 2). This sheltered setting has a bit more sediment buildup on the bed than other areas and is likely to have less large woody debris moving downriver than closer to the main current.
